# Characteristics of the Hănești tornado

Dumitru PANCU<sup>1\*</sup> and Sebastian PANCU<sup>2</sup>

Vol. 29 / 2019, 131-137

**KEY WORDS:** tornado, Hănești, Enhanced Fujita Scale.

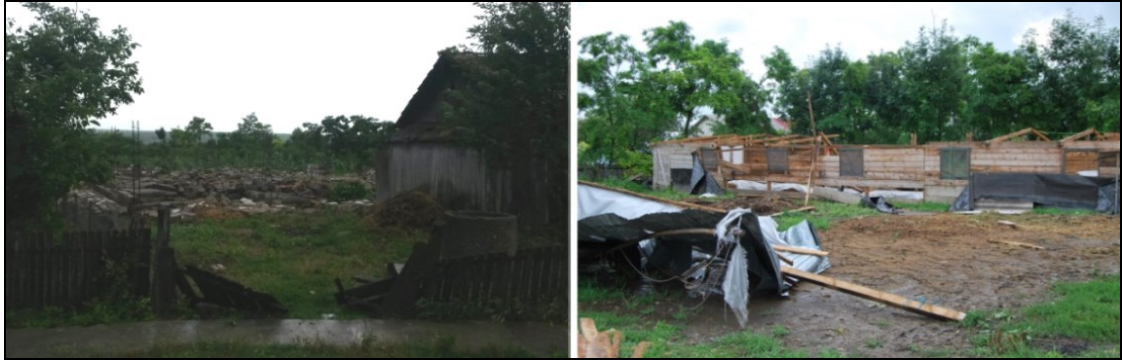
The tornado affected over 53 outbuildings covering over 1200 m<sup>2</sup> altogether, and numerous chimneys have been destroyed. The walls of a property in construction made of concrete reinforced with steel were destroyed entirely (Iordache family) (Fig. 4) and the roofs of two outbuildings were lifted (families Ailoei and Zahariuc). The age and low quality of adobe buildings lead us to choose the lower threshold of visible damage, meaning the minimum wind speed for this type of destruction, which is 130 km/h.

**Figure 4** Concrete outbuilding with destroyed walls (left), and outbuilding with roof lifted by wind and carried 50 m (right).

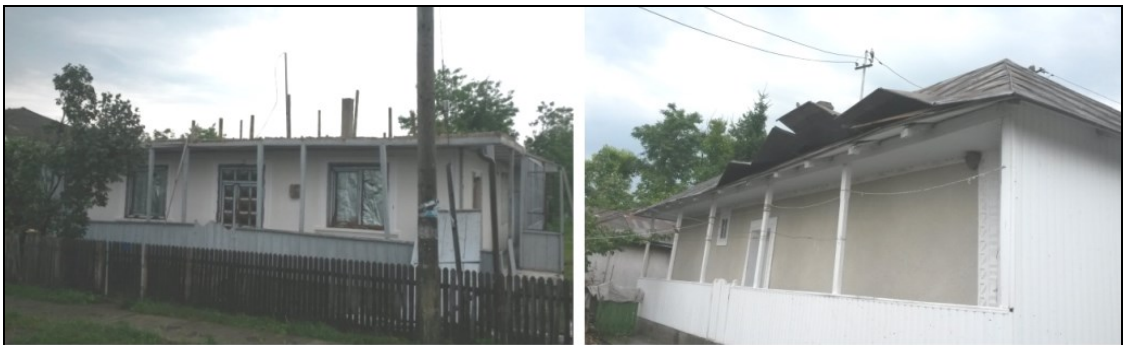
65 roofs were affected, with a total damaged area of 1,607 m<sup>2</sup>. The roofs of 44 buildings were damaged in proportion of over 20%, indicating wind speeds between 130-186 km/h. The presence of a tornado can also be assumed from the upwards separation of tin roofs (Fig. 5).

The roof of one particular house was carried by the wind over a distance of more than 150 m, and fragments of a roof were stuck by the wind to the top of a transmission line tower. We consider that the structure of the adobe houses does not conform to American construction norms since the roof is not firmly attached to the building's walls. As such, we once again took the minimum damage threshold, with a wind speed of 167 km/h.

**Figure 5** Building with roof separated and carried 150 m (left), and another building with a tin roof separated upwards (right).

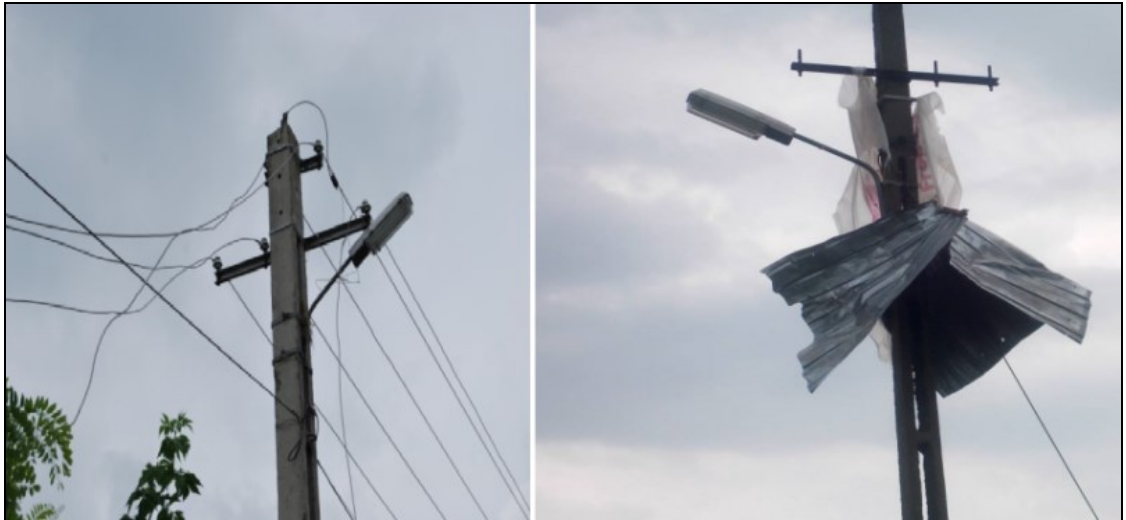
Certain towers had their wire supports removed, and even some metal bars were broken (Fig. 6). We considered the minimum visible damage threshold, with a wind speed 185 km/h.

**Figure 6** Broken steel bar (left), and a roof carried by the wind over a distance of circa 150 m (right).

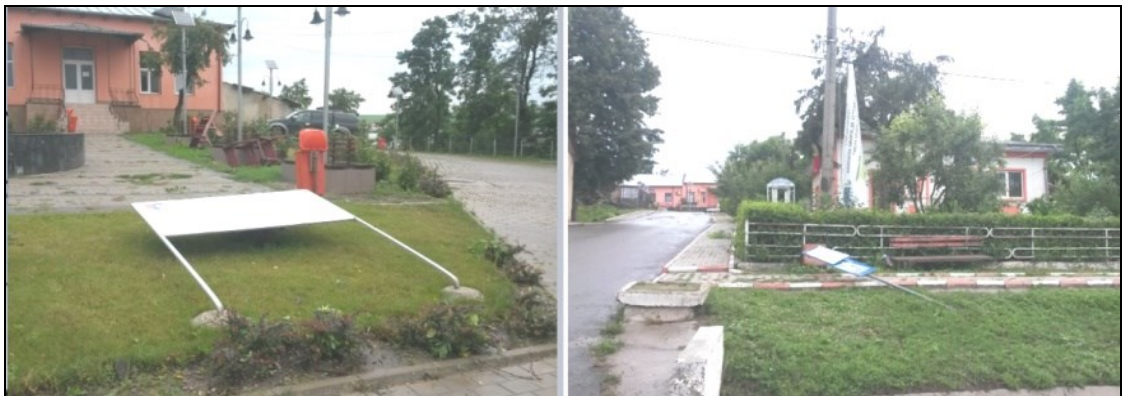
The wind had bent the support poles of signs to the ground (Fig. 7). Since the metallic support poles were small in diameter, we established the minimum damage threshold, with a minimum speed of 137 km/h.

**Figure 7** Metallic panels (left) and signs (right) bent to the ground.

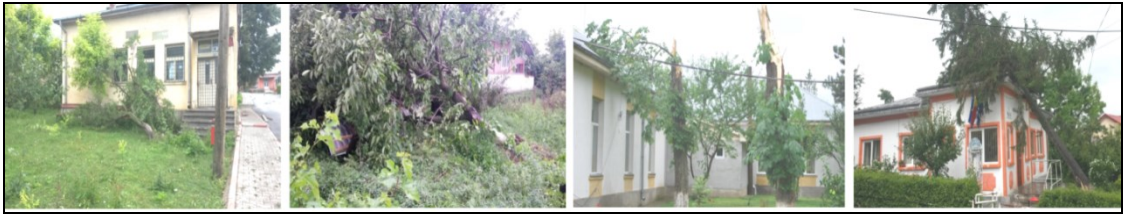
In the commune's center, multiple hardwood trees (acacia) with trunks measuring 30 - 40 cm in diameter were broken at approximately 1.0 - 1.5 m above ground level, indicating wind speeds between 150 - 215 km/h, and we chose to associate the maximum speed of 215 km/h, equivalent to grade IV of tree destruction. With numerous hardwood trees in the area being uprooted and contorted (Fig. 8), we associated the maximum value of this damage indicator, 118 mph or 190 km/h.

We consider these indicators to be appropriate and not in need of any adapting, since in the USA as well as Romania the same species of trees, both hardwood and softwood, can be found, and as such the necessary wind speed to cause this degree of destruction should not differ significantly between the two.

**Figure 8** Contorted tree (far left). Uprooted walnut tree (center left). Broken chestnut trees, with diameters of 30 - 40 cm (center right). Broken softwood trees with diameters of 30 - 40 cm (fir, spruce) (far right).
