Late Pleistocene and Holocene climatic variability in the Carpathian-Balkan region. Abstracts volume

Changes of the hydrodynamic conditions in the braided river

Karol Plesiński and Artur Radecki-Pawlik

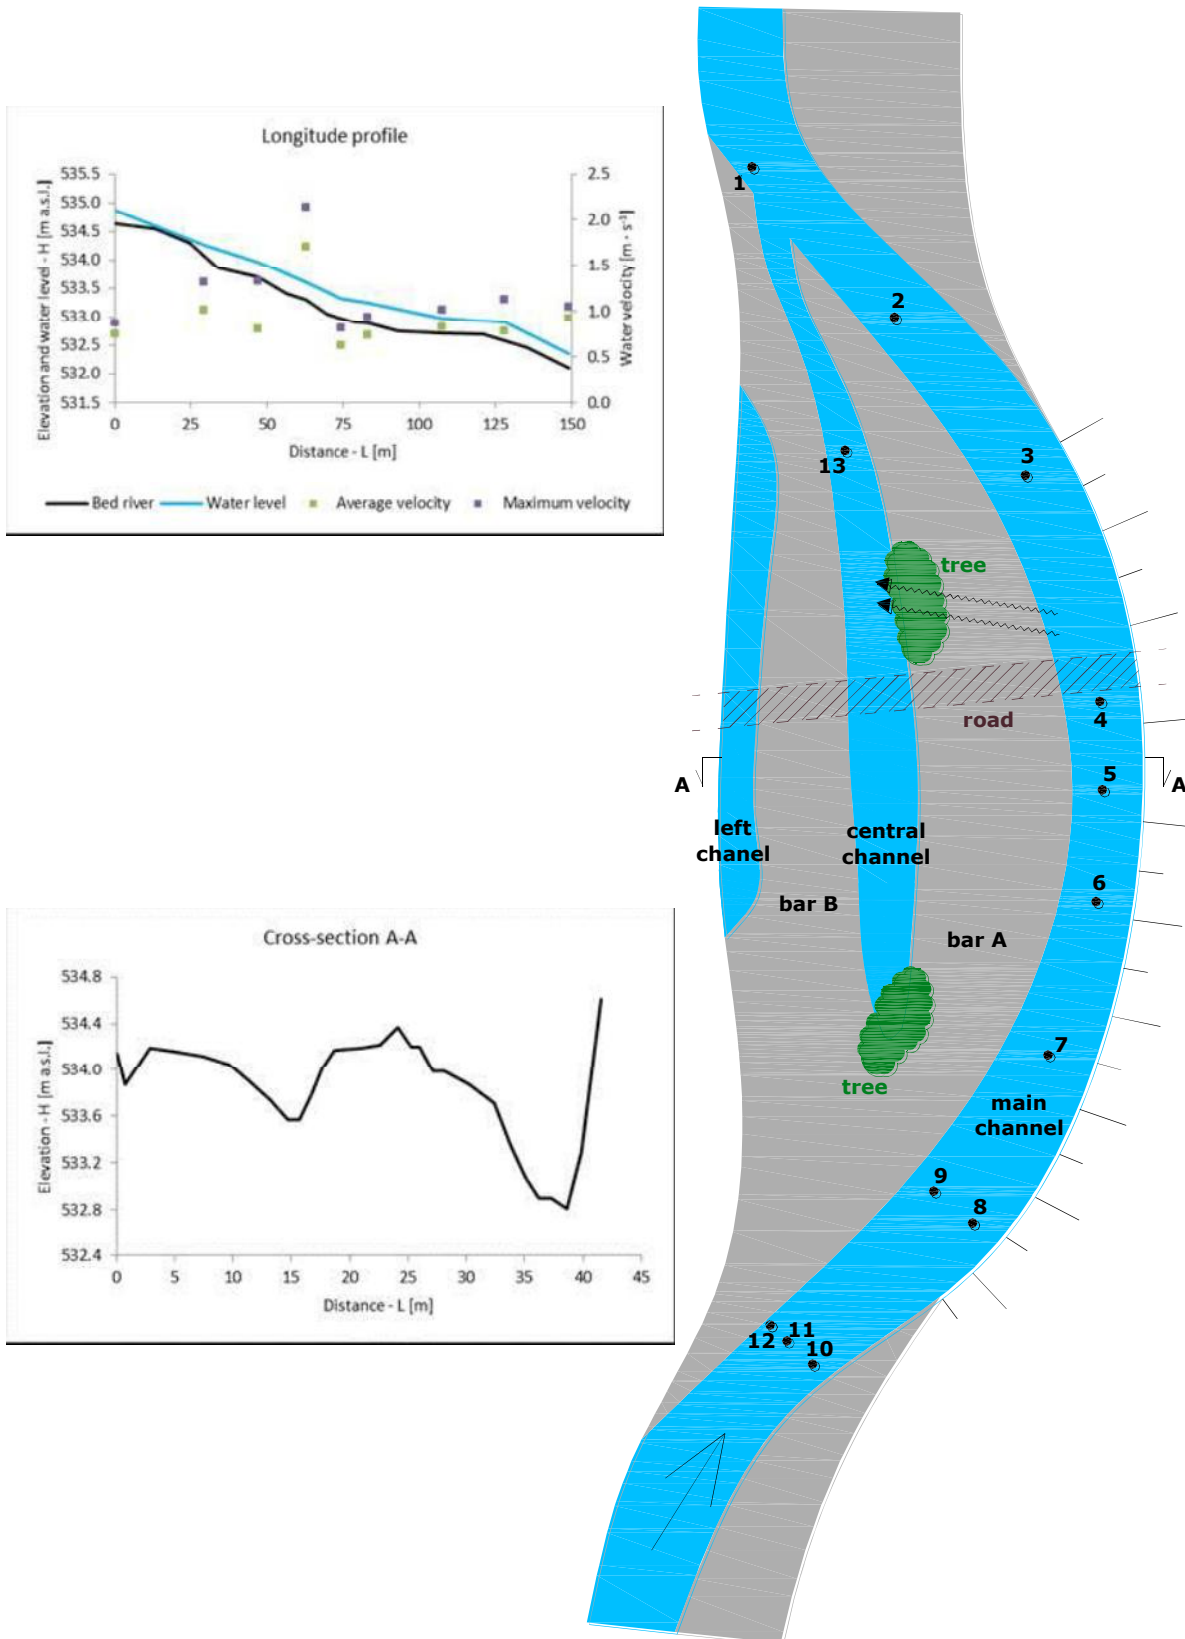
Fig. 6 Channel system during the 5th series measurement

In 25.08.2014, we performed cross-section and longitude profile measurement on the Ochotnica River (Fig. 6). Additionally, we made hydrodynamics parameters measurement during the flow $Q = 1.5 \text{ m}^3 \cdot \text{s}^{-1}$ (Tab. 5). The river was reconstructing its bars by depositing gravel. We observed two gravel bars and three water channels (one main and two side). The water flowed one out (main channel) of three channels. The river cuts the right bank.

In the central channel, the water flows during the medium water level. In the comparison with measurement day (25.08.2014), the water level must be grow up about 0.37 m. Then the water may be flow into the central channel through the local road. At measurement day, the water get to the central channel across the alluvial material of bar A, which was located below the road. In the left channel was dry. The water was only during in the high water level.

The values of velocity in the main channel were noticed $V_{av} > 0.63 \text{ m} \cdot \text{s}^{-1}$. The highest value ($V_{av} = 1.70 \text{ m} \cdot \text{s}^{-1}$, $V_{max} = 2.14 \text{ m} \cdot \text{s}^{-1}$) was obtained at the point 6. In this place were observed a few over-sized grains, what caused the appearance a very turbulence ($Re = 490\ 788$). At the point 9, we also measured the high value of velocity ($V_{av} = 1.16 \text{ m} \cdot \text{s}^{-1}$) and the low value of water depth ($h_{max} = 0.13 \text{ m}$). At this place, we observed a riffles in the bed river.

In the central channel, the water either stagnate or flowed with the low speed. At the point 13, the velocity value was noticed ($V_{av} = 0.22 \text{ m} \cdot \text{s}^{-1}$). The other hydrodynamic parameters were also lower than observed in the main stream. The value of shear stress was equaled $\tau = 0.096 \text{ N} \cdot \text{m}^{-2}$. The values of Reynolds number and Froude number was noticed $Re_{max} = 14\ 984$ and $Fr_{max} = 0.338$ respectively.
