The General Urban Plan of Casimcea territorial administrative unit, map of natural and anthropogenic risks

KEY WORDS: Risks, Casimcea Plateau, General Urban Plan

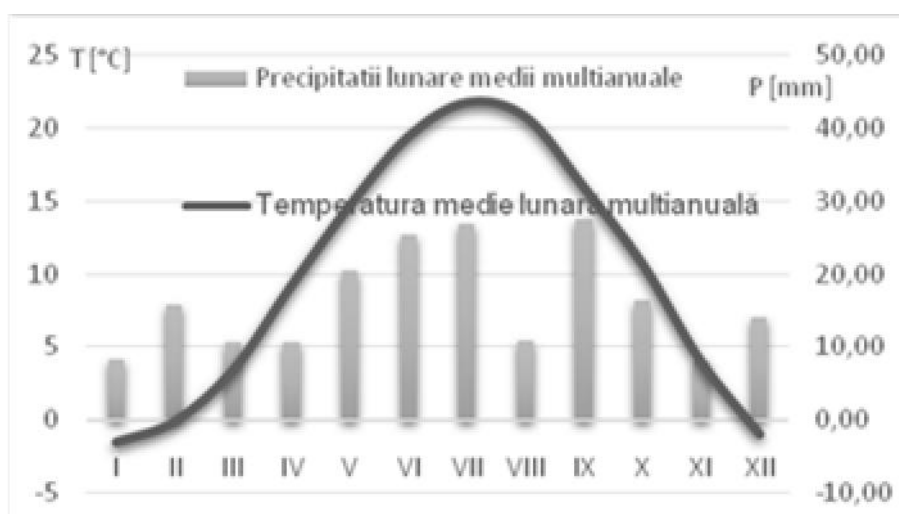
Figure 1. Multiannual monthly average temperature and monthly average precipitation annual at Corugea station (220 m altitude). Climograma Walter-Lieth in dual scale (1986-2000).

The analysis of temperature variation correlated with rainfall using climograma Walter-Lieth in double and triple scale (figure 1) for the period 1986 – 2000 reveals dryness, or drought. Dry period is usually between mid May and late October, but in the analyzed period (1986-2000) there is an extension of three months (mid-March to end of November).

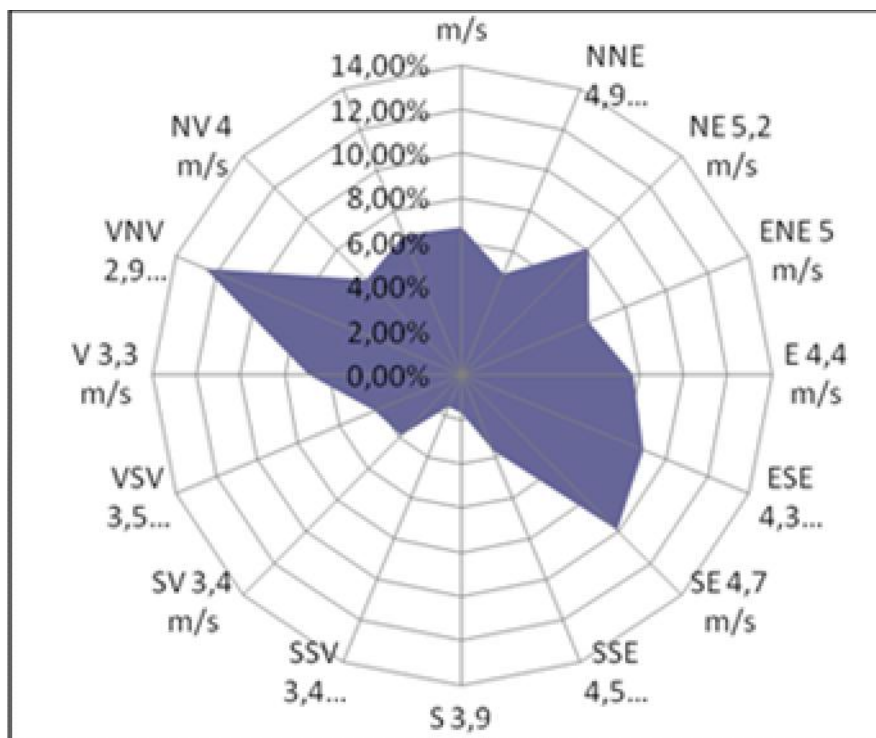
Figure 2. Wind frequency and wind average speed in the direction at the meteorological station Corugea (2008-2012).

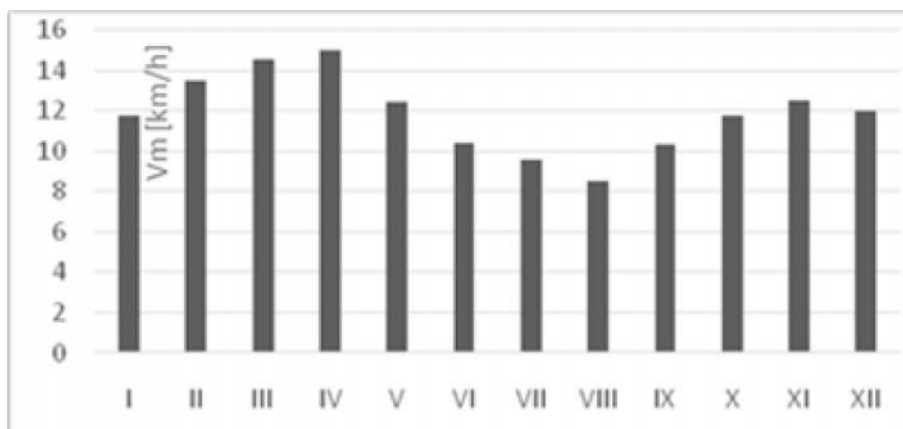
Figure 3. Monthly average wind speed, 1986-2000 at the meteorological station Corugea.

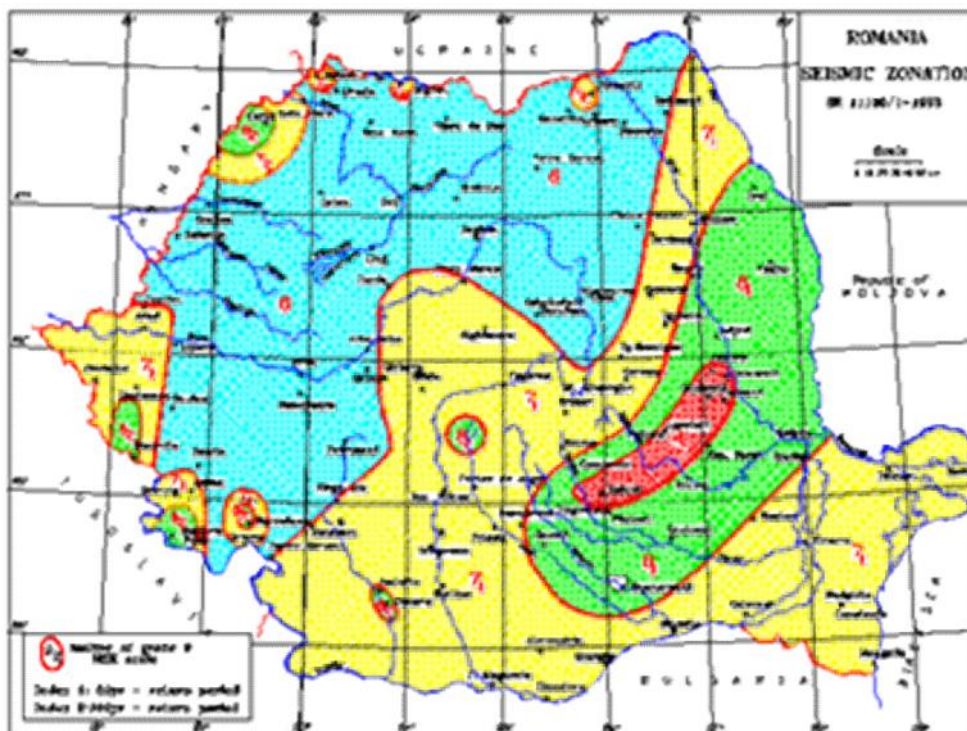
Figure 4. Seismic Zoning of Romania in MSK degrees of intensity (by UTC, București).

Casimcea administrative territory, Tulcea county, belongs to zone 7 degrees MSK of seismic intensity according intensity zoning of Romania (STAS 11100/1-93), having a return period of 50 years (Figure 4).

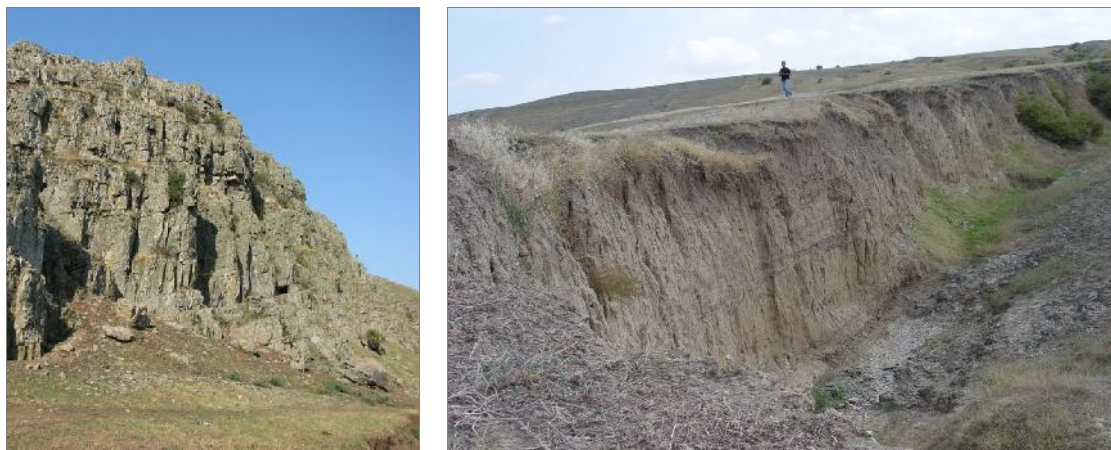
Figure 5. Gravitational processes (rockfalls – Colțanu Mare, falls of bank river-Mahomencea Valey).

The falls of bank rivers are frequently due to uncohesion of deposits of the valley. They meet along the steep banks of valleys Topolog, Casimcea and Mahomencea.

Rockfalls is natural risk factor which can act only local in outside villages zones, where the green schists are at surface (Colțani), in sectors of Topolog River (Rahman and Haidar) with its tributary brook Mahomencea (Corugea village and the area of former village Stâncea) and Casimcea River (Războieni and Casimcea).

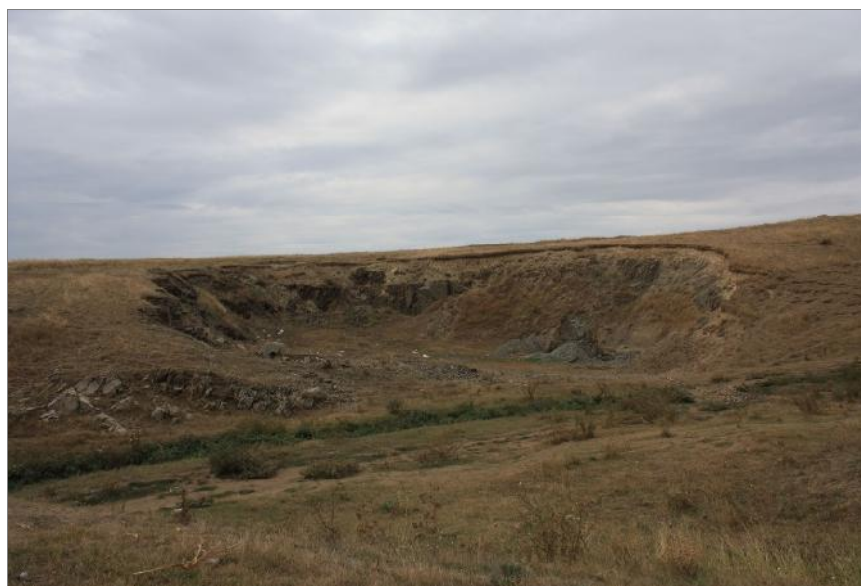
Figure 6. Compaction and pipping.

The compaction and pipping are the result of undermining of above deposits by water infiltration and water circulation in poorly cohesive permeable deposits. The process is enhanced by specific semiarid climat, the drought favors the appearance of cracks in soil and the rainfall produce erosion and removal of particles. Other forms of this process are: pipping pits and chimneys, pipping galleries and tunnels and pipping valleys.
