# Characteristics of the Hănești tornado

Dumitru PANCU<sup>1\*</sup> and Sebastian PANCU<sup>2</sup>

Vol. 29 / 2019, 131-137

**KEY WORDS:** tornado, Hănești, Enhanced Fujita Scale.

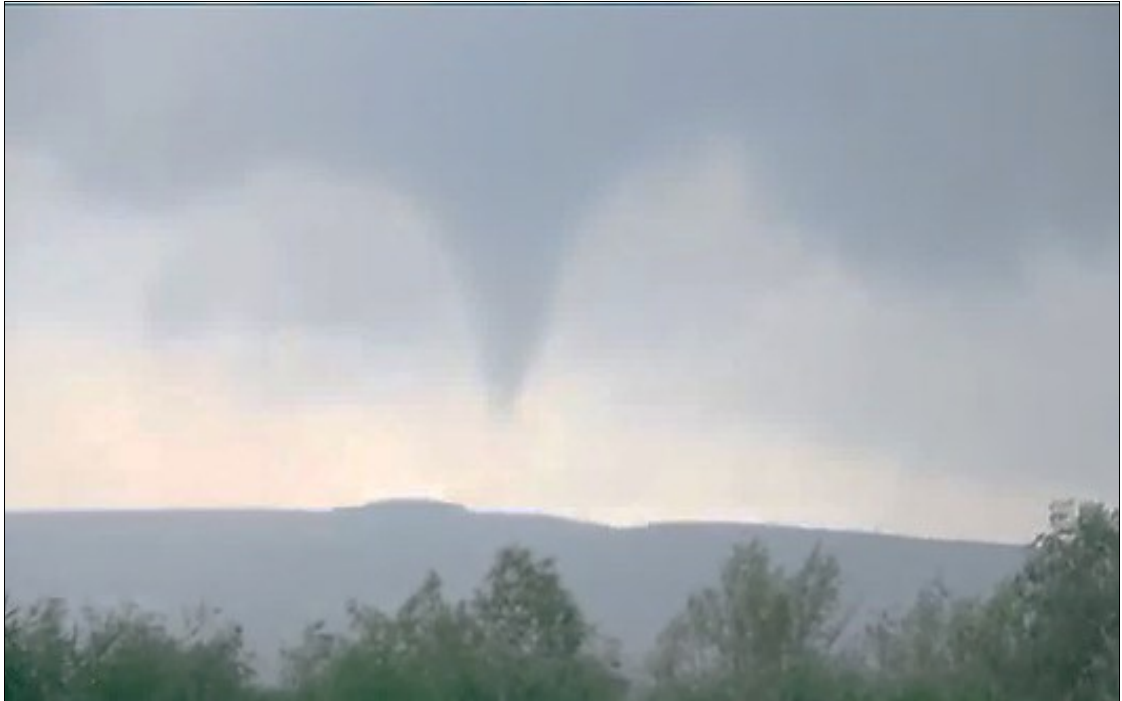
The data taken from the Botoșani weather station indicate that cumulonimbus clouds (60-80%), often anvil-shaped, stagnated from 11 PM on the 10<sup>th</sup> of July 2014 to 7 PM on the 11<sup>th</sup> of July 2014 at an altitude of 600-1000 m. (Source: <http://www.rp5.ru>). A video recording of the Hănești meteorological phenomenon (Fig. 1) presents an anticyclonic tornado with a visible funnel in contact with the ground as well as the tornado cloud.

**Figure 1** Tornado cloud, 11<sup>th</sup> of July 2014, Hănești (Botoșani). Source: Romanian Meteorological Society Bulletin, No. 3, September 2014, pg. 30.

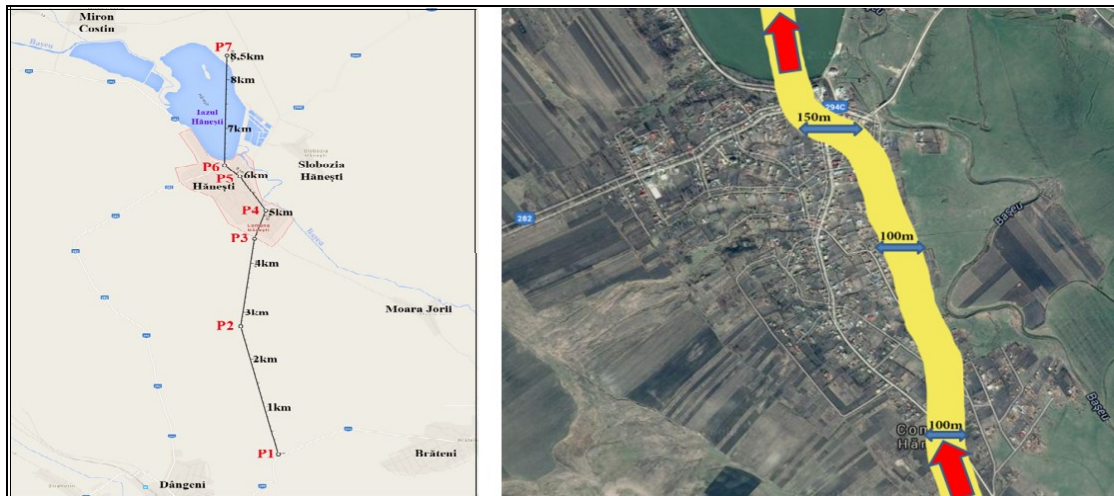
As can be seen in the map created following field research (Fig. 2), the tornado was formed in an open field outside the commune, towards Brăteni, going between points P1 and P3 on a distance of 4.5 km, and then moved from East to West inside the commune of Hănești between points P3 and P6 on a distance of 2 km. The tornado's diameter increases to circa 150 m in the center of the commune causing the greatest damage, and finally it moves on the surface of the Hănești Lake, becoming a waterspout (by raising water) and decreasing in intensity towards the commune of Miron Costin. From the locals' accounts, one person, namely Ilie Tomniuc, was carried by the wind circa 100 m, and as the vortex moved, a noise similar to that of an airplane in flight could be heard. The Hănești meteorological phenomenon was associated with electrical discharge and torrential rain over a period of 20 min which fragmented the asphalt road (Fig. 3). The quantity of rainfall

**Figure 2** The path of the tornado on the 11<sup>th</sup> of July 2014 on the territory of the commune of Hănești, Botoșani County. Source: <http://www.google.ro/maps>, processed in Adobe Photoshop.
